GLENGARRY PIONEER MUSEUM

SUBJECT: Physical Plant Policy

### **PHYSICAL PLANT POLICY**

# LAYOUT, BUILDINGS AND SITE UTILITIES

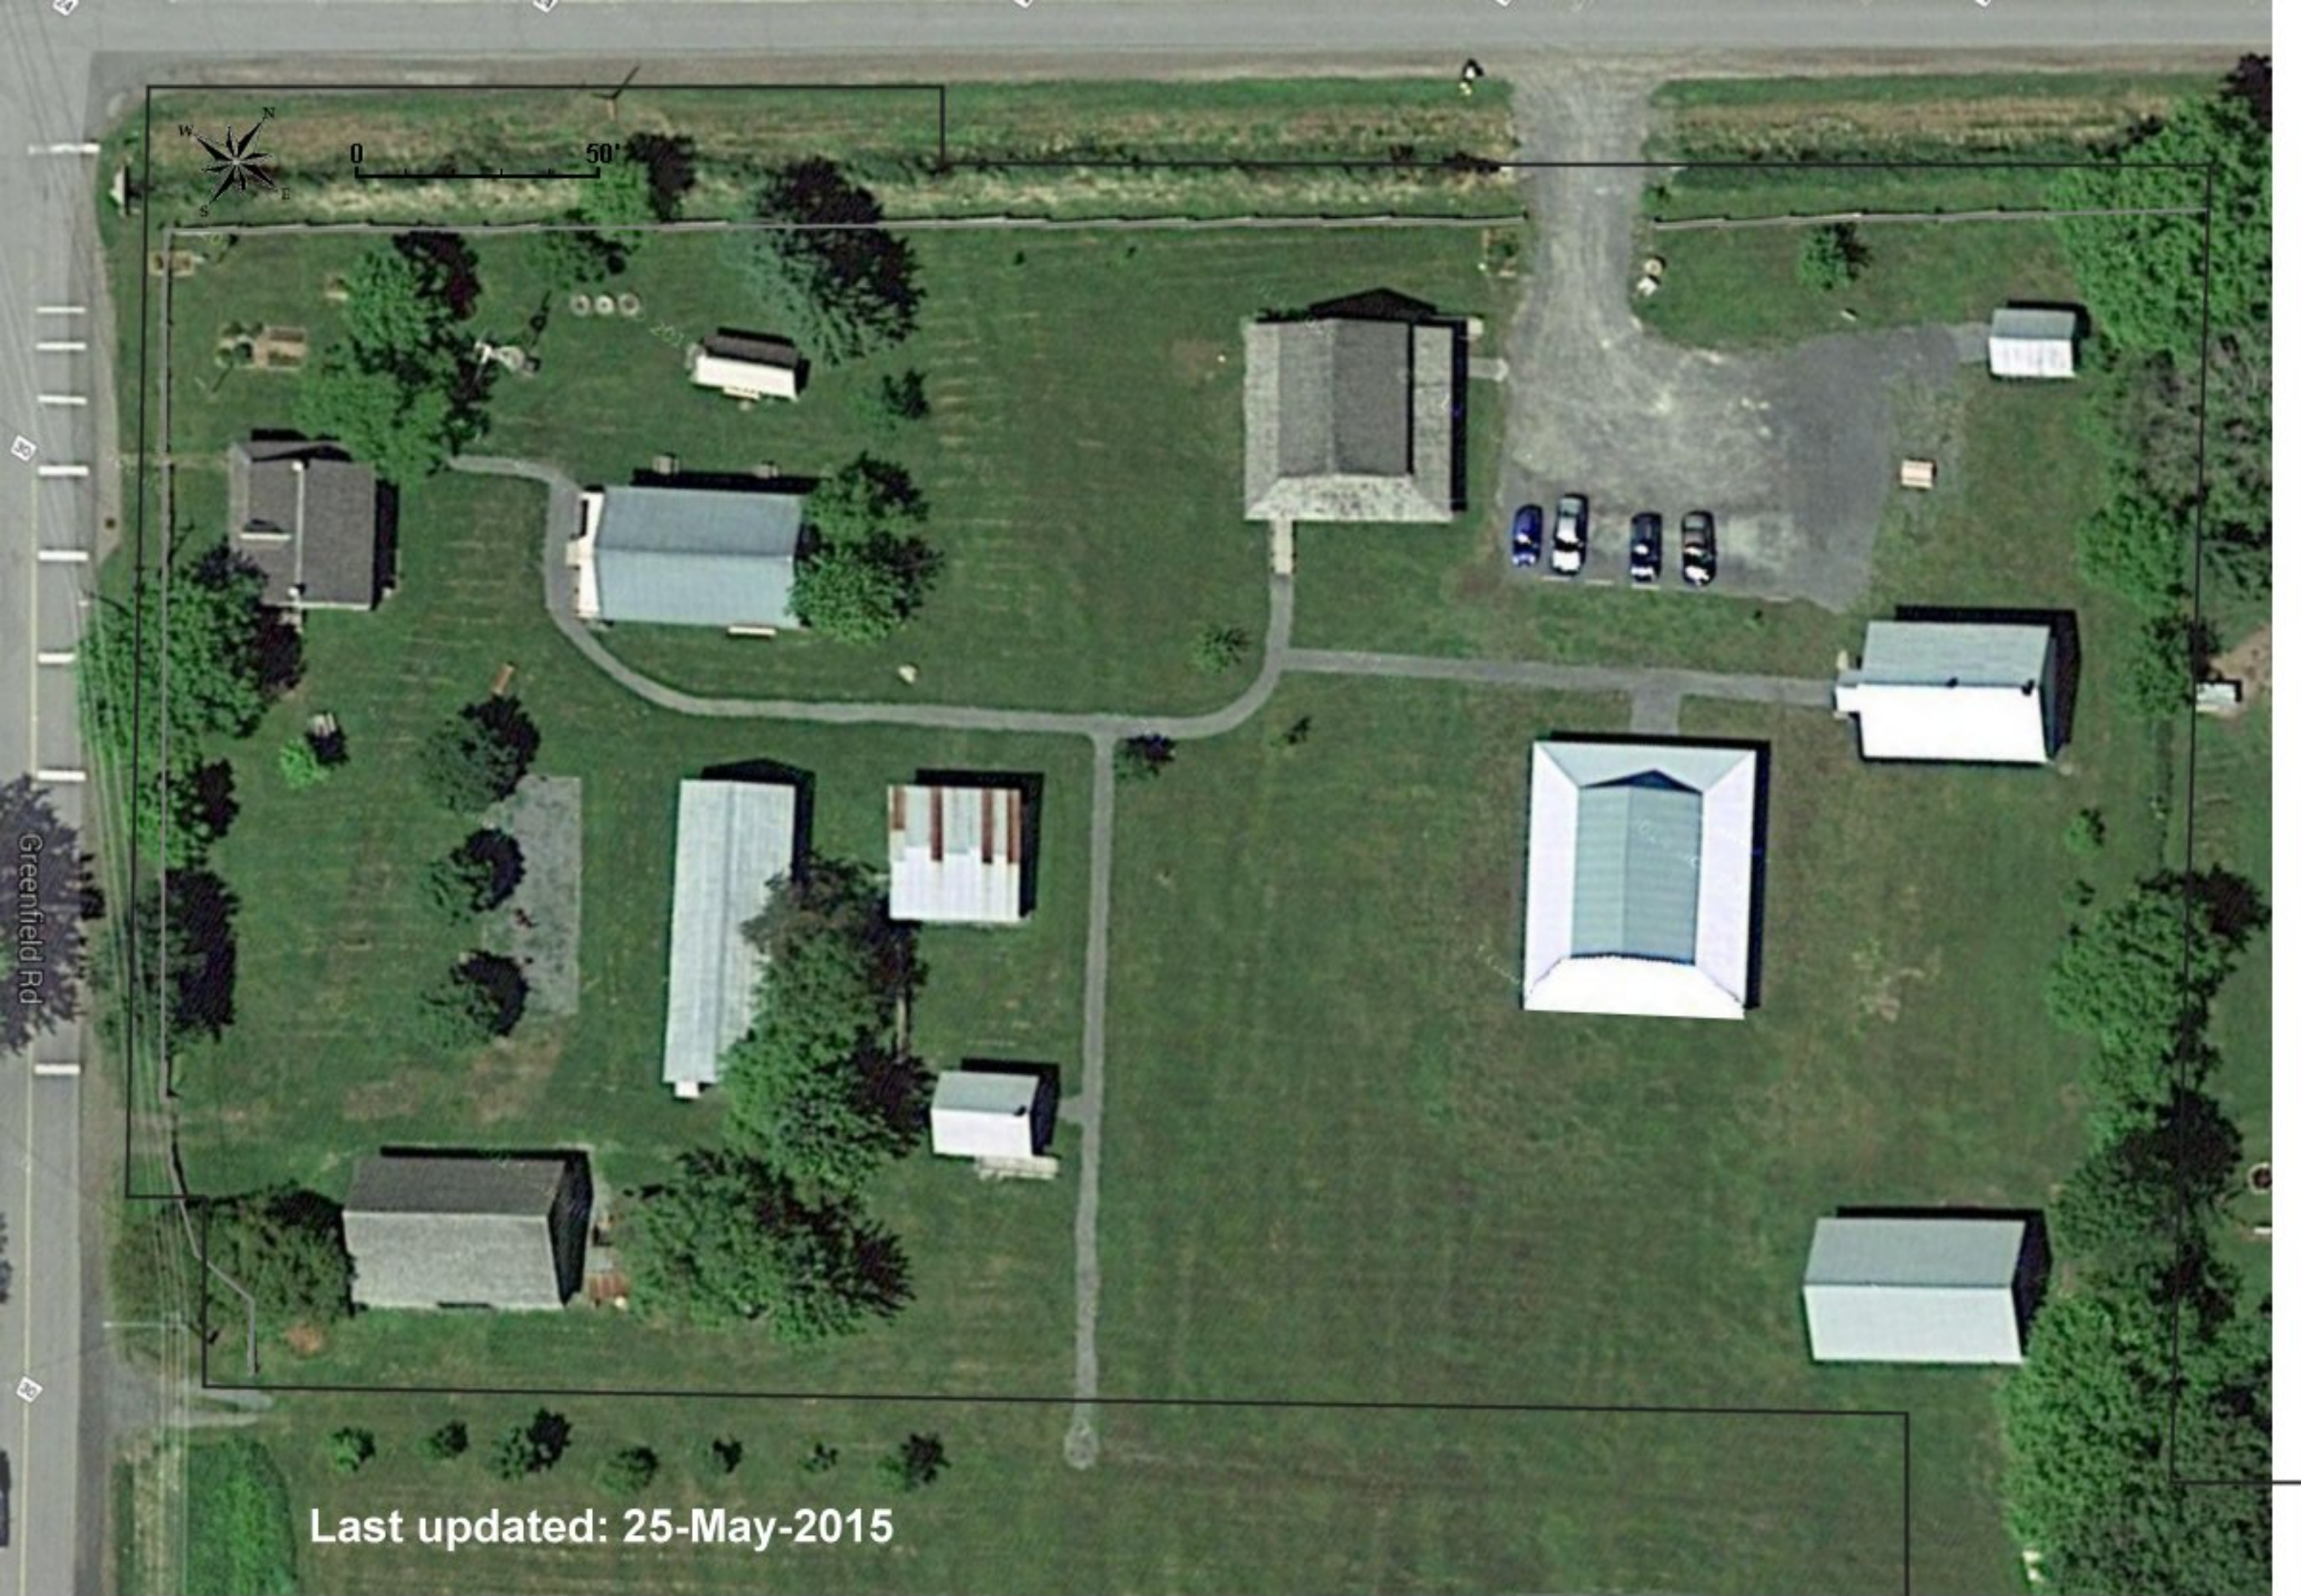
Appendix A – Site Layout (maps)

The physical location of the buildings on the Museum site is shown in *Annex 1 – Appendix A – Site Layout*.
